Waterline Resources Inc. was retained by Brookfield Residential Inc., Genesis Land Development Corp. and Mr. Sandy Soutzo to update the existing hydrogeological conceptual model in support of the Ricardo Ranch Area Structure Plan (ASP) in Southeast Calgary, Alberta. The Ricardo Ranch ASP is part of a greater ASP Development, which comprises approximately 1,346 hectares of land in the southeast quadrant of Calgary, south of the Seton Urban District. Ricardo Ranch is located within Sections 9, 10 and 11, and parts of Sections 3 and 4, of Township 22, Range 29, West of the Fourth Meridian. Its boundaries are marked by Highway 2 (Deerfoot Trail) and the Bow River.

PROJECT
 Preliminary Hydrogeological Assessment
 Ricardo Ranch Area Structure Plan
 Southeast Calgary, Alberta

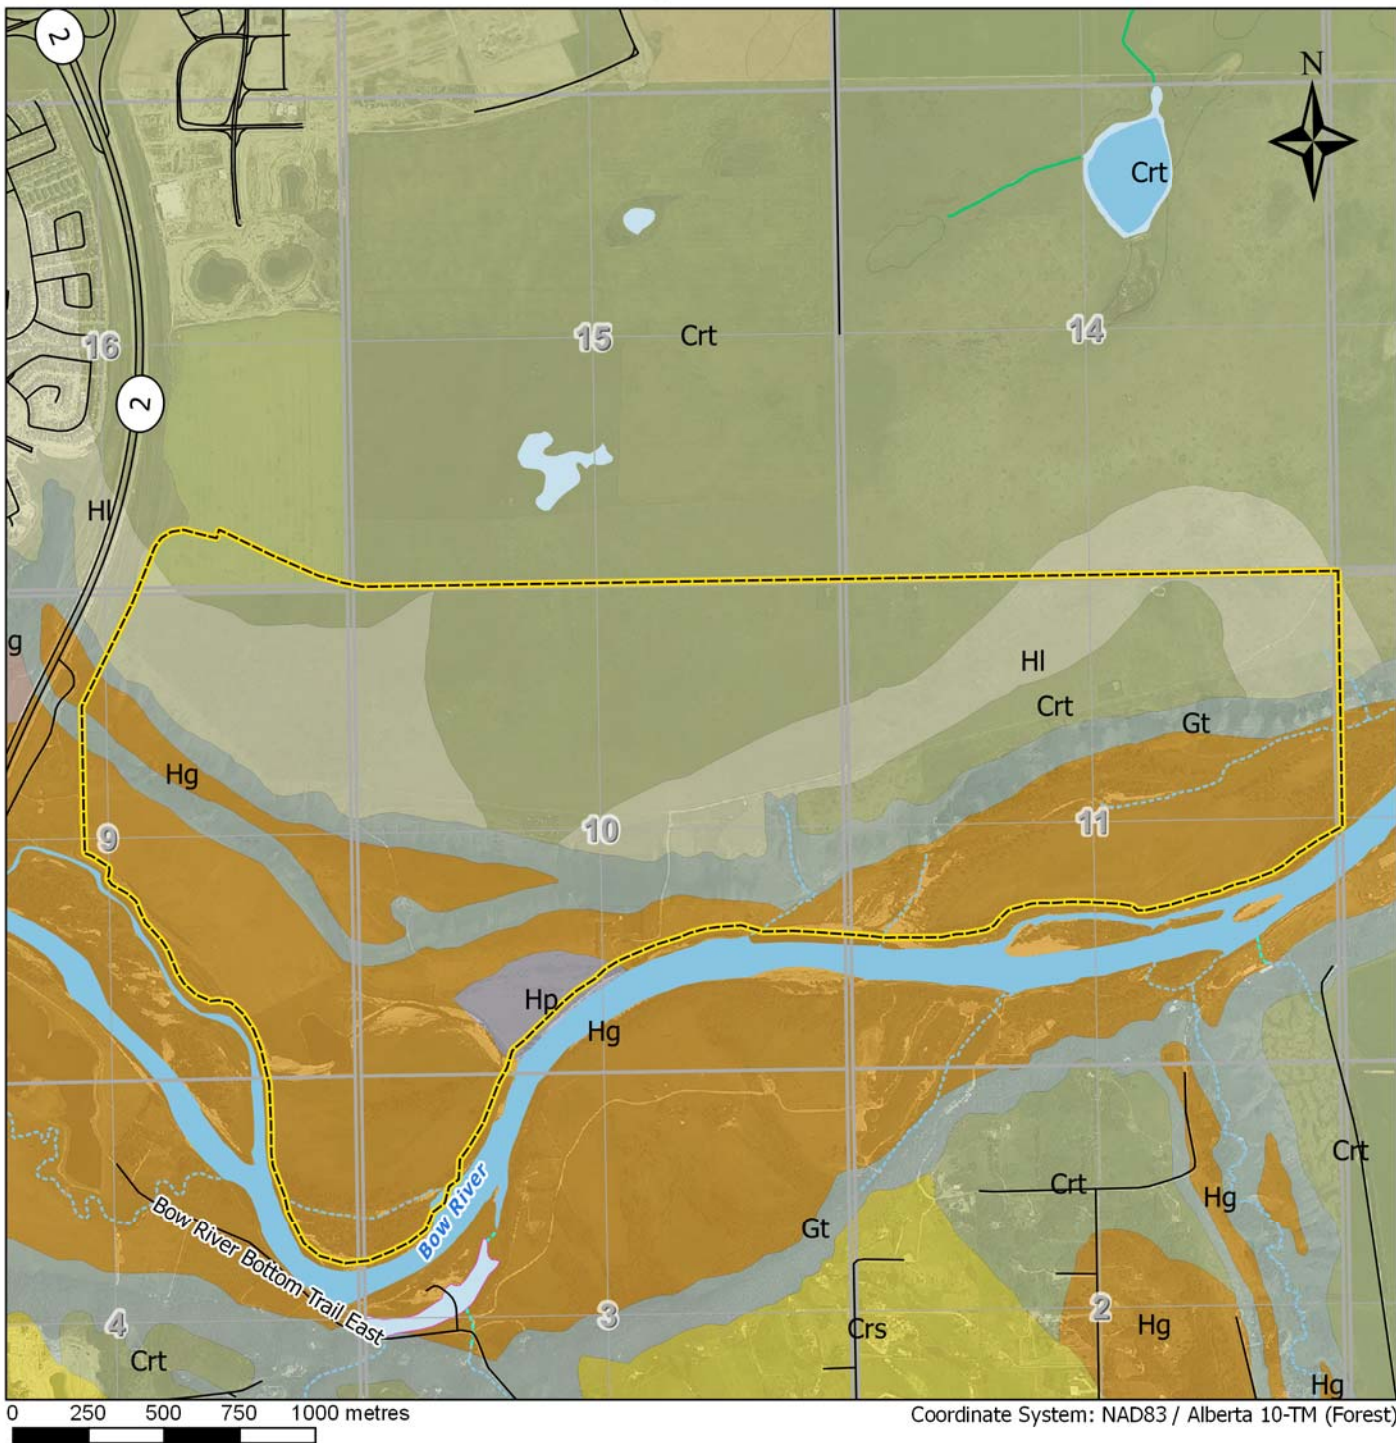
<p>Preliminary Hydrogeological Assessment Ricardo Ranch Area Structure Plan Southeast Calgary, Alberta</p>	
<p>SURFICIAL GEOLOGY</p>	
<p>Prepared By: Waterline Resources Inc. Project Number: 2961-18-001 Compiled By: jmsulak Date Issued: 2018-Jul-12 Date Revised: --</p>	<p>FIGURE 3</p>

The surficial geology of the plateau and escarpment in the study area have been mapped as the glacially deposited Crossfield Drift by Moran (2008; Figure 3). The Crossfield Drift is described as consisting of clay-dominated (Unit A) and sand and silt-dominated (Unit B) till sediments. Below the escarpment, Moran (2008) identifies Empress Formation sediments as well as fluvial-channel sediments, originating from the Bow River, consisting of sands and gravels. The regional geology is shown on the regional cross-sections A and B, developed by Moran (2008) that occur proximal to the study area (Figure 5).
